FLAHERTY-GIAVARA ASSOCIATES NEW HAVEN CT
NATIONAL DAM SAFETY PROGRAM. LAKE MUSKODAY DAM (INVENTORY NUMBRE--ETC(U)
SEP 81 H C FLAHERTY

REPORT DOCUMENTATION PAGE		READ INSTRUCTIONS BEFORE COMPLETING FORM
1. REPORT NUMBER	2. GOVT ACCESSION NO.	3. RECIPIENT'S CATALOG NUMBER
	AD A309969	
4. TITLE (and Subtitle)	5. TYPE OF REPORT & PERIOD COVERED	
Phase I Inspection Report Lake Muskoday Dam Delaware River Basin, Sullivan County, NY Inventory No. NY00341	Phase I Inspection Report National Dam Safety Program

LAKE MUSKODAY DAM
INVENTORY No. NY 341
DELAWARE RIVER BASIN
SULLIVAN COUNTY
FREMONT, NEW YORK

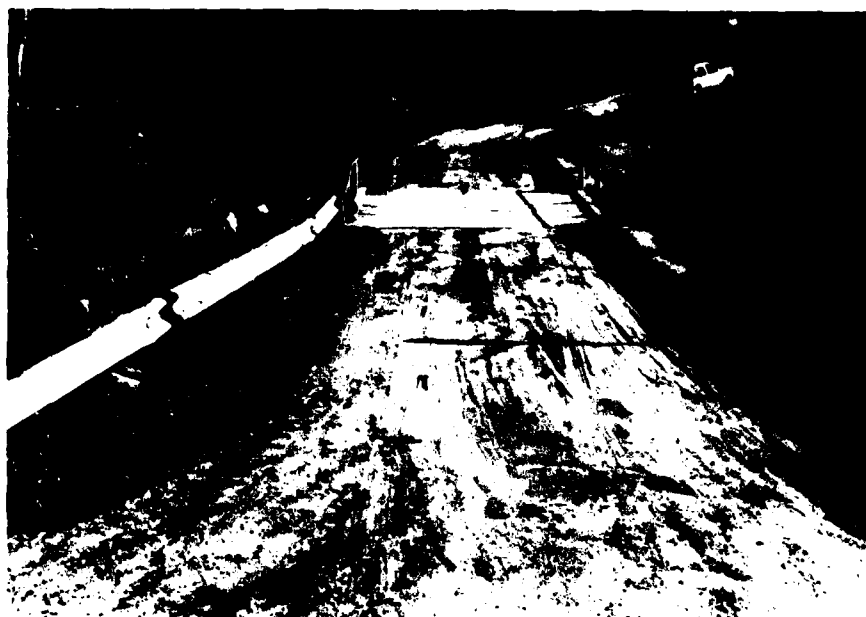
PHOTO #3: Crest of dam looking toward right
abutment

3. The partially-paved roadway along the dam crest has local shallow potholes, apparently due to traffic under wet conditions (See Photo No. 3).
4. At either end of the dam, the downstream rockfill slope has weeds and brush, some debris and at least one tree among the rock fragments (See Photos No. 10 and 11).

- (1) Vertical Alignment Good; except for local small depressions (potholes)
- (2) Horizontal Alignment Good; substantially straight
- (3) Surface Cracks None observed
- (4) Miscellaneous Small depressions (potholes) apparently from traffic during
wet conditions; grass at edge of road

- a. Clear brush, trees and debris from the downstream rock-fill, and recut at least annually to maintain the cleared condition.
- b. Fill and regrade the local potholes on the dam crest, and grade the roadway and its side ditches to avoid detrimental erosion at the dam.
- c. Place rockfill or riprap erosion protection where the upstream earthen embankment has been eroded by wave action.
- d. Develop and implement a flood warning and emergency evacuation plan to alert downstream residents in the event conditions occur which could result in failure of the dam.
- e. A program for regular maintenance should be developed and implemented.

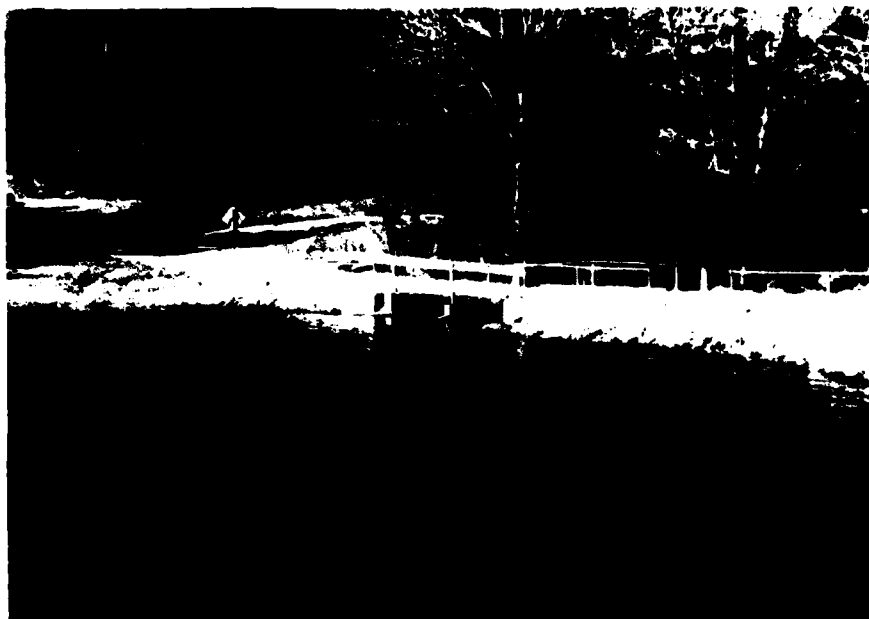
PHOTO #4: Overview of upstream face of dam

The masonry and stone fill dam structure is generally in fair condition (See Photos No. 4 and 5). There was no visible evidence of significant lateral movement or settlement, or major erosion, but there was moderate water flow from the rockfill on either side of the spillway.

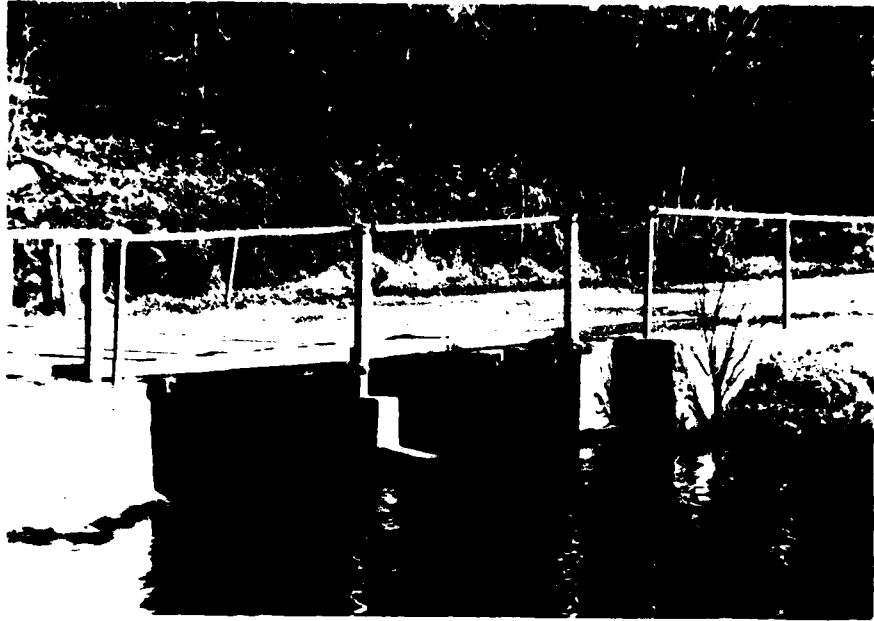
PHOTO #8: Spillway from upstream

The overflow spillway consists of a 17.4 foot wide broad-crested weir and rockfill apron (See Photos No. 8 and 9). A timber plank and steel beam bridge spans the weir, which was free of debris and in good condition at the time of inspection.

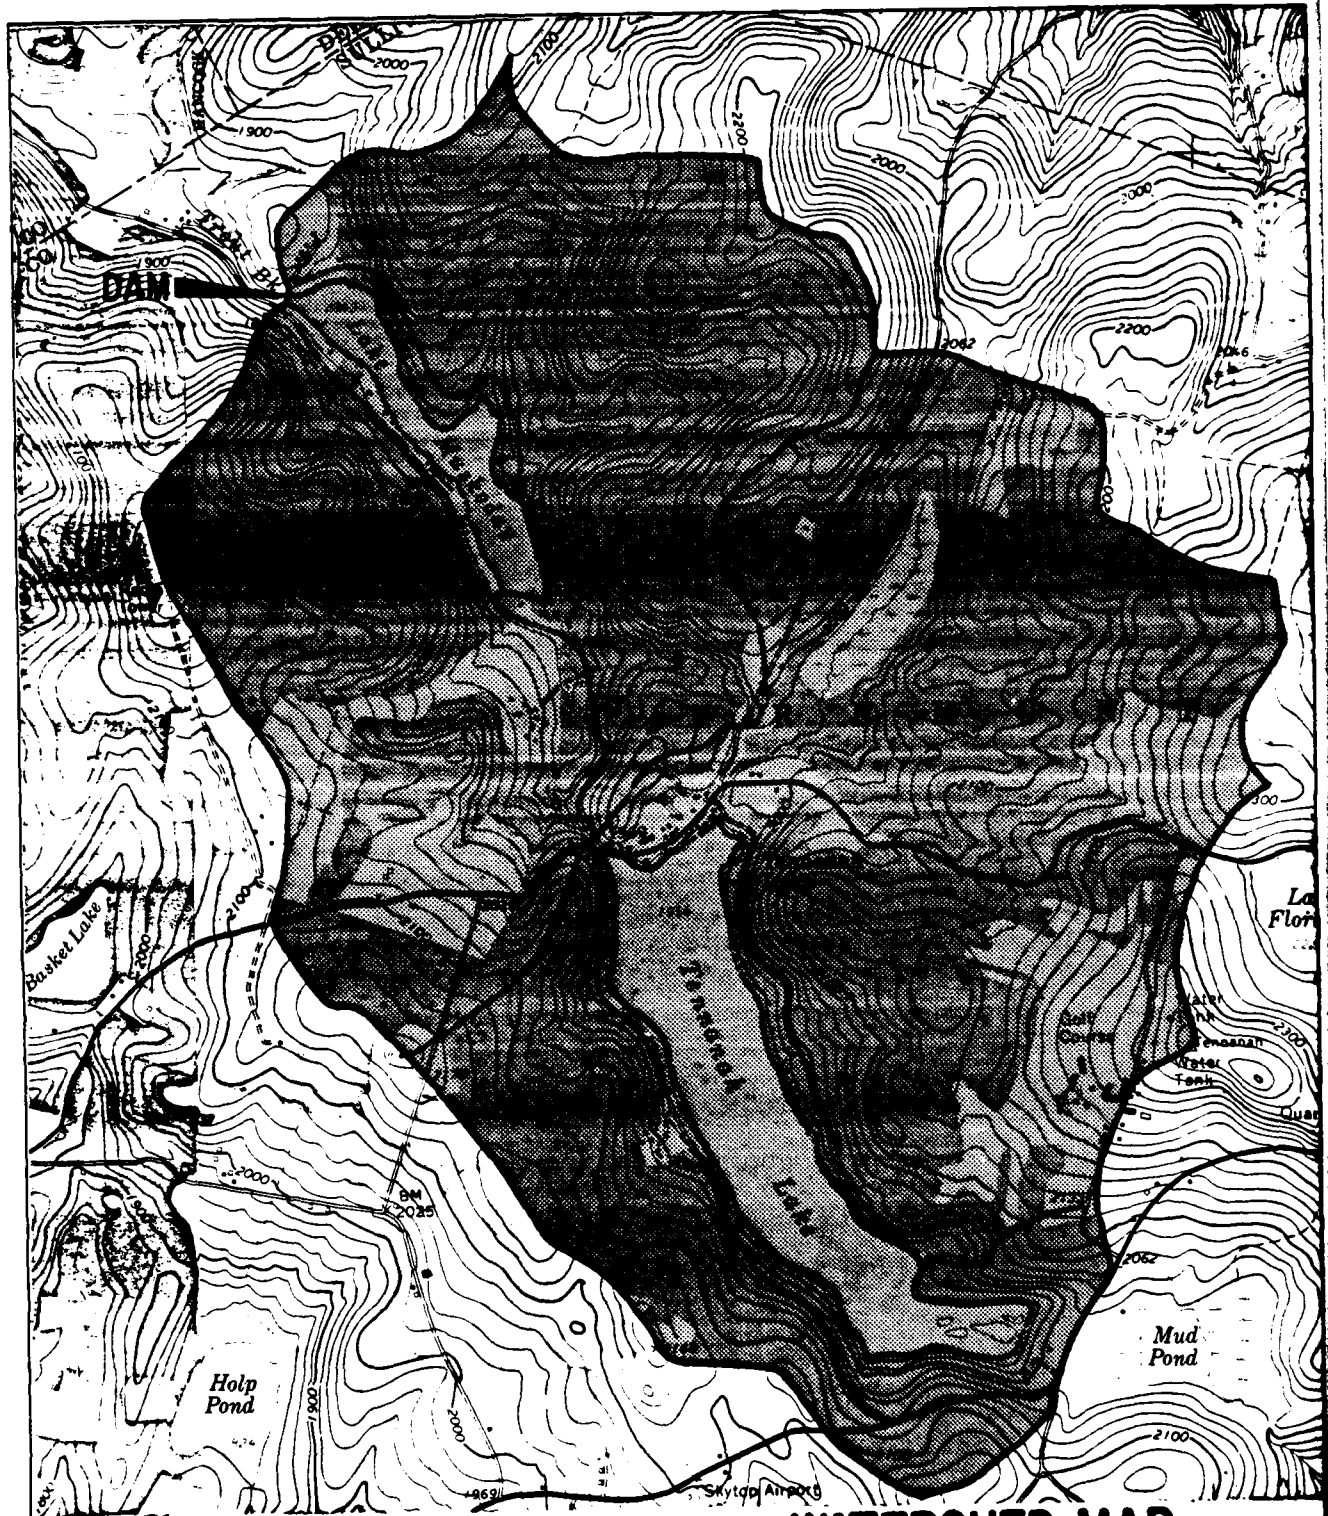
WATERSHED MAP

Length @ Maximum Pool 4500 \pm feet = 0.9 miles (Miles)

Length of Shoreline (@ Spillway Crest) 10,500 \pm feet=2.0 miles (Miles)
